SPECTRA ENGINEERING PTY LTD

MX800 Important Firmware Update

MOTHERBOARD BUILD VERSION C OR LESS WITH NEW RELEASE FIRMWARE

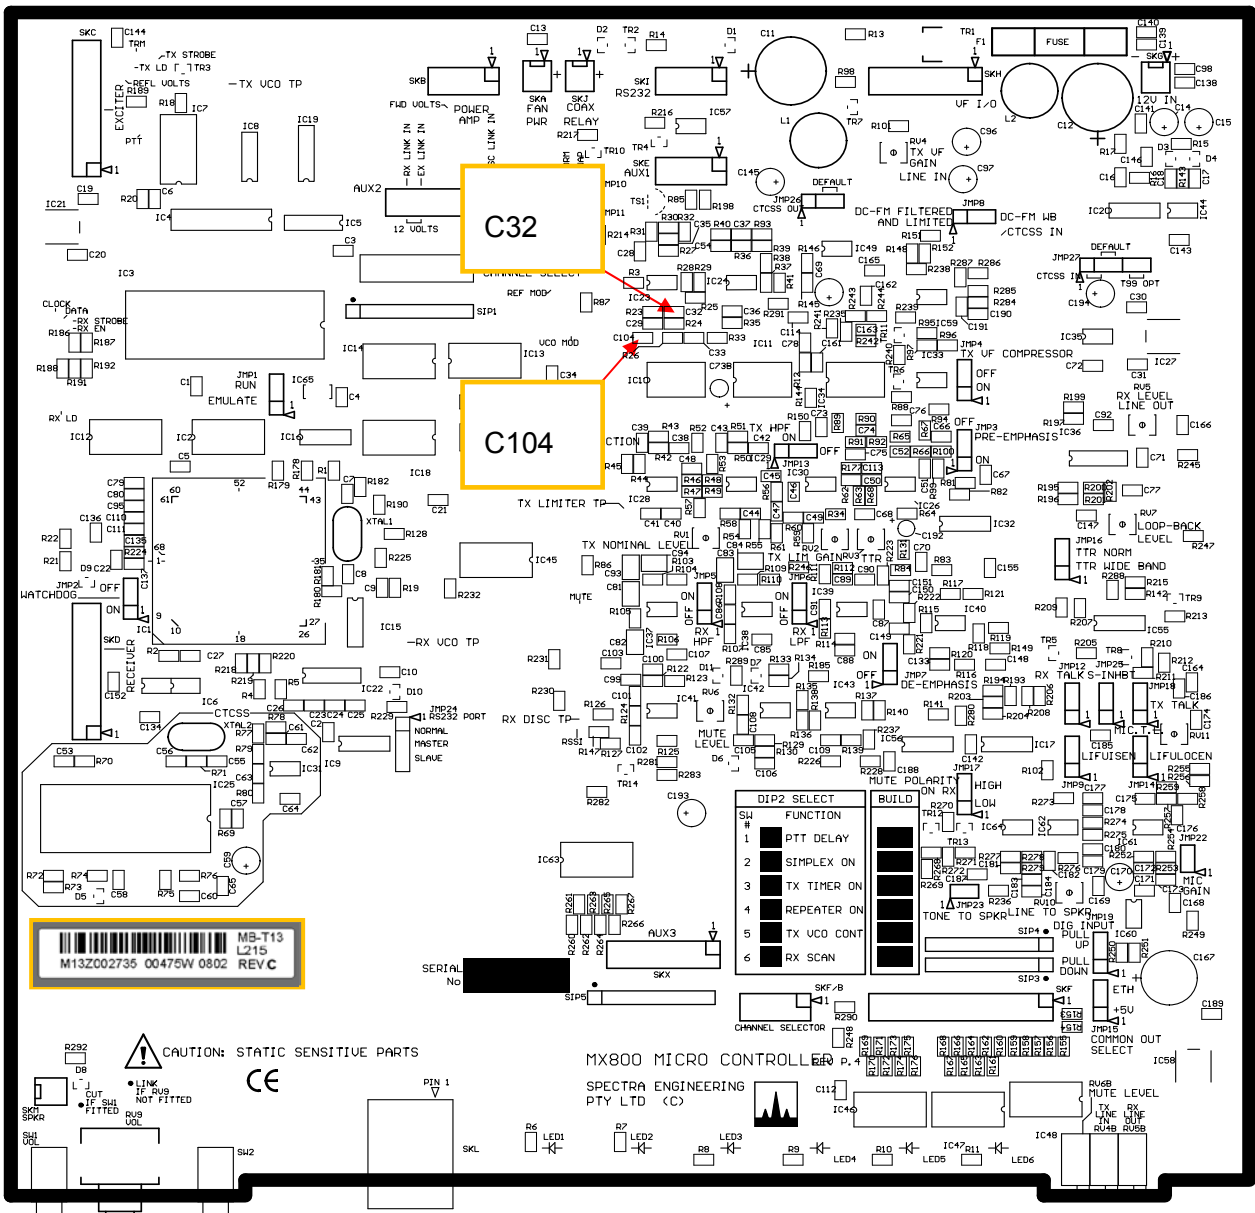
The only way to correct the identified issues is to swap mother board PCB components C32 & C104 over when upgrading firmware.

REMOVE	C32	1nF 0805 X7R
FIT	C32	10nF 0805
REMOVE	C104	10nF 0805
FIT	C104	1nF 0805 X7R
